BEAM DUMPING SYSTEM AND ABORT GAP

J. Uythoven, CERN, Geneva, Switzerland

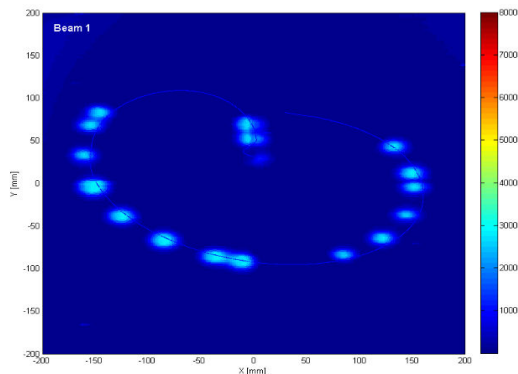
At 450 GeV the beams were dumped correctly, showing the expected pattern on the beam screen just in front of the beam dump block (BTVDD), see Fig. 1, and no significant beam losses in the extraction area and beam dump channel were measured.

For a beam energy of 1.2 TeV the beam was found to be 7 – 8 mm low on the BTVDD for both beams. This could be an MSD (extraction septum) calibration issue and will be corrected during 2010 operation when required.

Figure 1: BTVDD image of beam 1, for a beam dump of 16 bunches plus one pilot bunch (14/12/09 around 21:00).

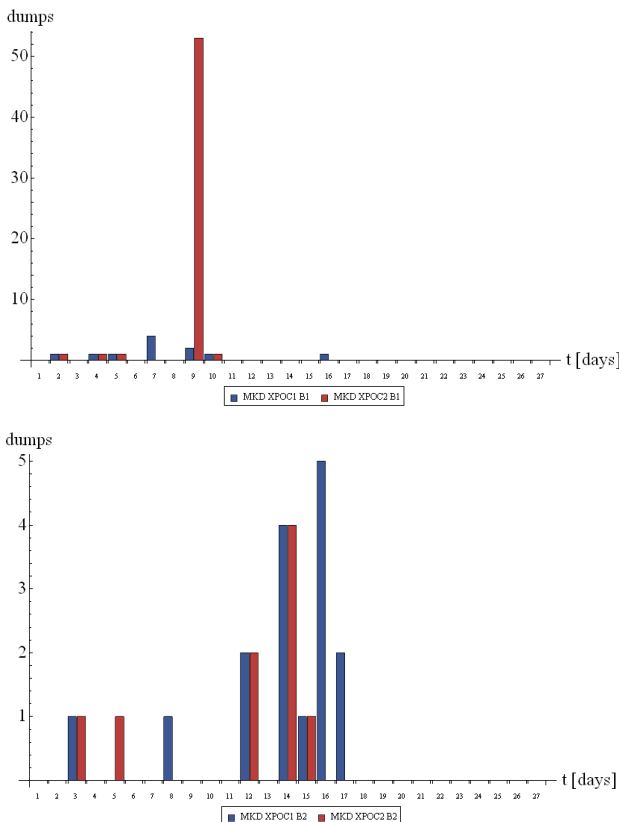
During the operational period of 20 November to 16 December 2009 a total 1366 dumps were analysed for beam 1 and 1175 dumps for beam 2, of which only 7 dumps at 1.2 TeV for both beams. The number of false XPOC results as a function of time are shown in Fig. 2. It shows that for both beams there were no false XPOCs over the last 10 days of operation.

For the MKD beam 1 system about 50 faults occurred on a single day, due to a varying pulse length on generator K. This was temporarily solved by doubling the XPOC acceptance window of the pulse length of this generator. Inspection during the technical stop over Christmas

showed a loose contact on this generator, which was repaired.

For the MKD B2 system the faults are more distributed. They were partly due to noise on the XPOC1 signals (solved by doubling the acceptance window, which are now the standard settings for both beams) and an ‘energy error’ in the analysis, solved during operation by applying the correct tolerances.

Figure 2: Number of MKD XPOC faults for beam 1 (top) and beam 2 (bottom).

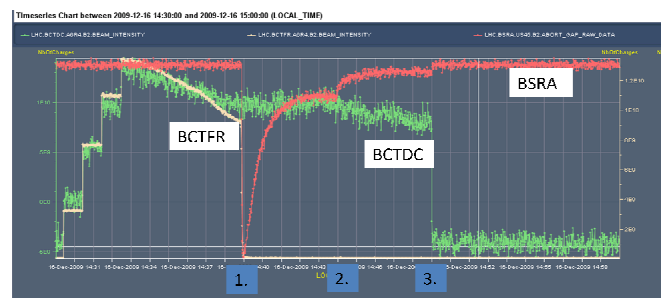
First functionality tests of the abort gap cleaning were performed during the last days of operation in 2009. The vertical dampers were used on beam 2. The most interesting measurement is shown in Fig. 3: After four injections and some time with stored beam the RF is switched off at moment (1). The BCTFR reading goes to zero and the intensity reading goes to ‘maximum’ immediately, as the four injected bunches were close to the abort gap. After 5 minutes (2) the cleaning is switched on and an equilibrium between cleaning and abort gap repopulation is obtained after 1 – 2 minutes. At (3) the beam was dumped. During the dump, the losses at the BLMs located at the TCDQ and TCDS were reduced to 10 – 12 % of the losses at these elements without cleaning.

From the experience so far it can be concluded that for beam 2 the abort gap cleaning already worked during the first tests, however further optimisation is required to clean over the full $3\mu\text{s}$ of the abort gap and limiting the losses outside the abort gap.

Figure 3: Beam current measurements by the BCTFR and the BCTDC together with BSRA intensity measurements (zero intensity at the top) as a function of time.
