VCSEL Failures in ATLAS

T. Flick, University of Wuppertal
TWEPP 2010 Aachen, 20.09-24.09.2010

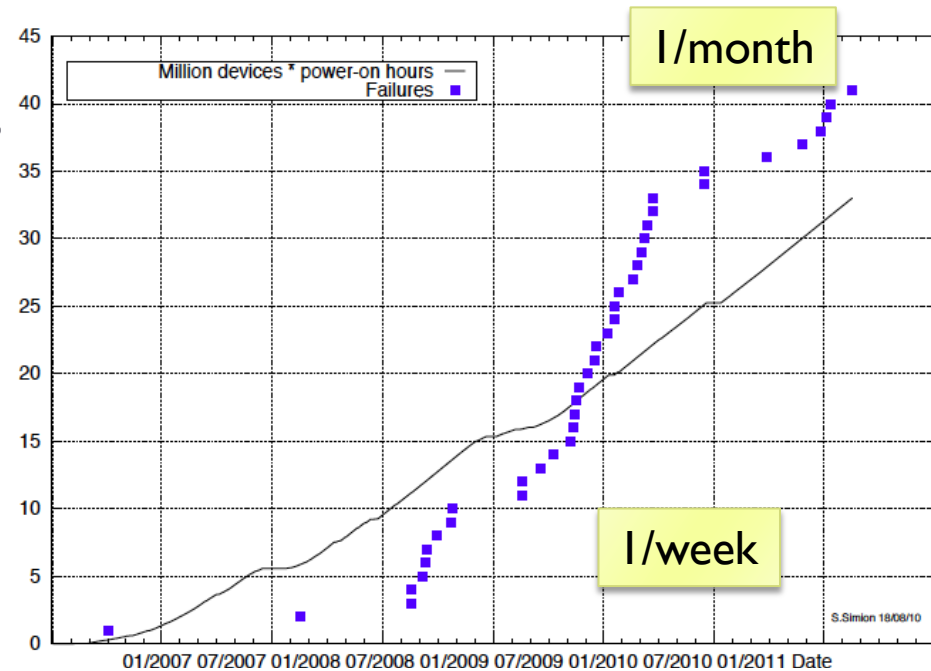
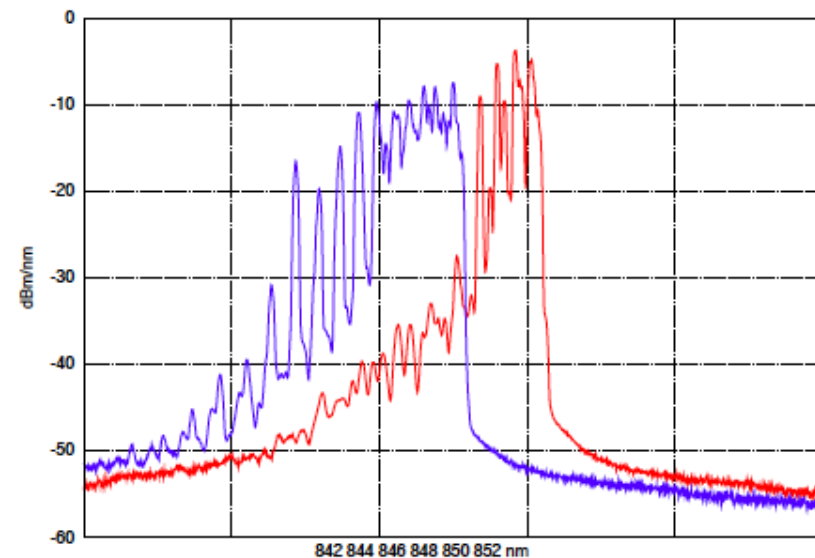
LArg VCSEL failures

- ▶ Failure rising started in 2008.
- ▶ Changed I-V curve for death lasers has been observed.
- ▶ Used optical spectrum measurements for indicating damaged lasers → Exchange them.
- ▶ From investigation of the VCSEL surfaces (EL, TEM, ...):
 - ▶ Hint that the failed VCSELs had a processing defect (irregular growth of oxide aperture → stress in the active region?).
 - ▶ Attempts to trace the propagation of the defect from the oxide aperture down to the active region were not successful until now.

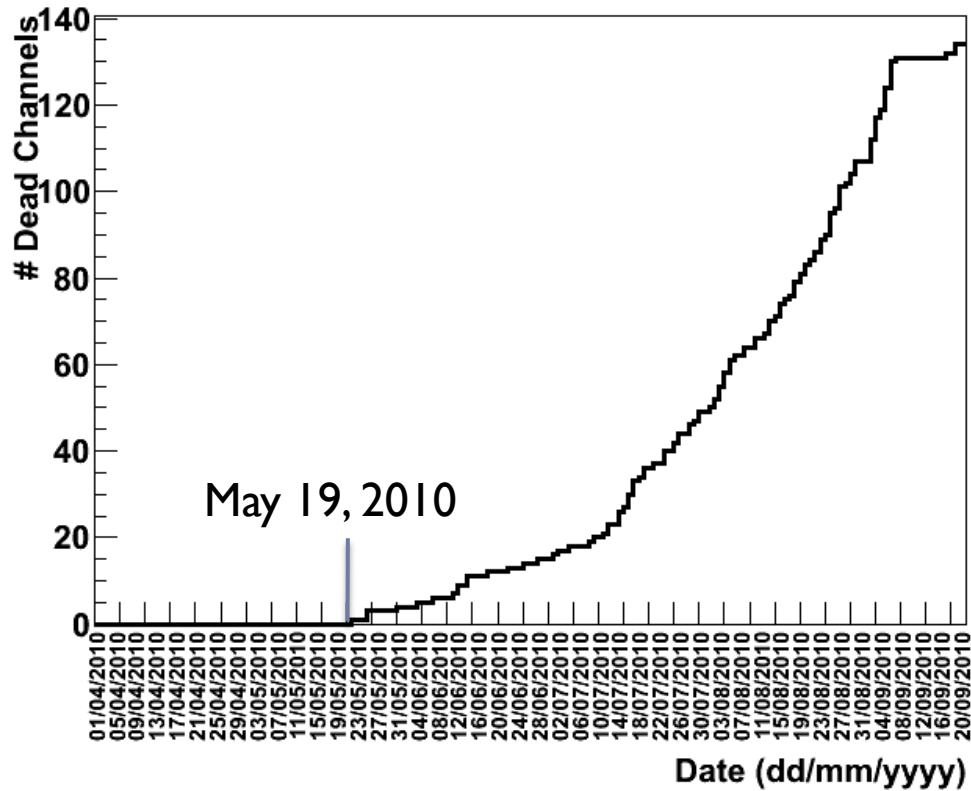
Number of SCT Tx Deaths since 01/04/2010

~135 failed channels
Rate is ~15/week

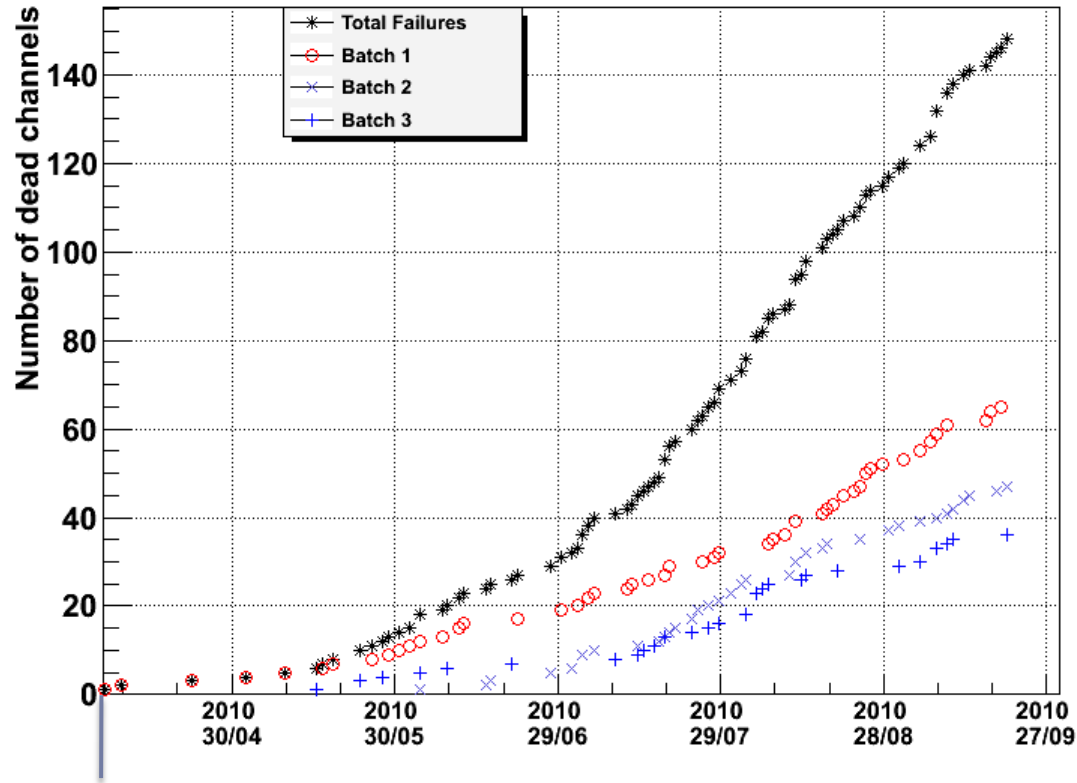
Death Timeline

~145 failed channels
Rate is ~13/week

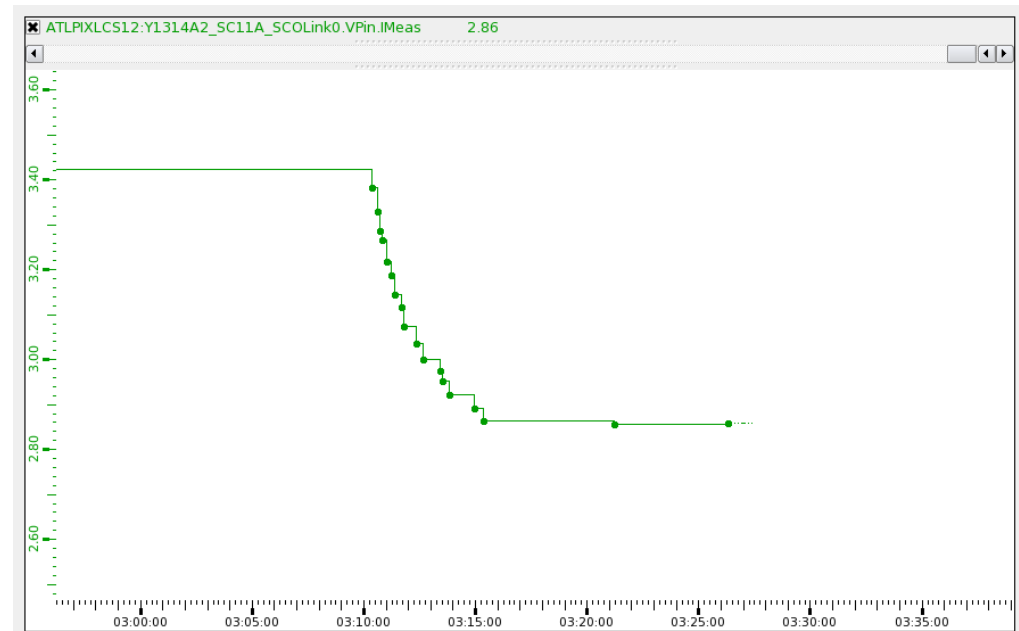
Characteristic

- ▶ The light output power of the array is measured in the pixel setup (all channels together).
- ▶ It is stable just before the dead of a channel
- ▶ While dying the light power drops over 5-10 mins.
- ▶ And then it is stable again.
- ▶ The lost channel does not emit any light anymore.

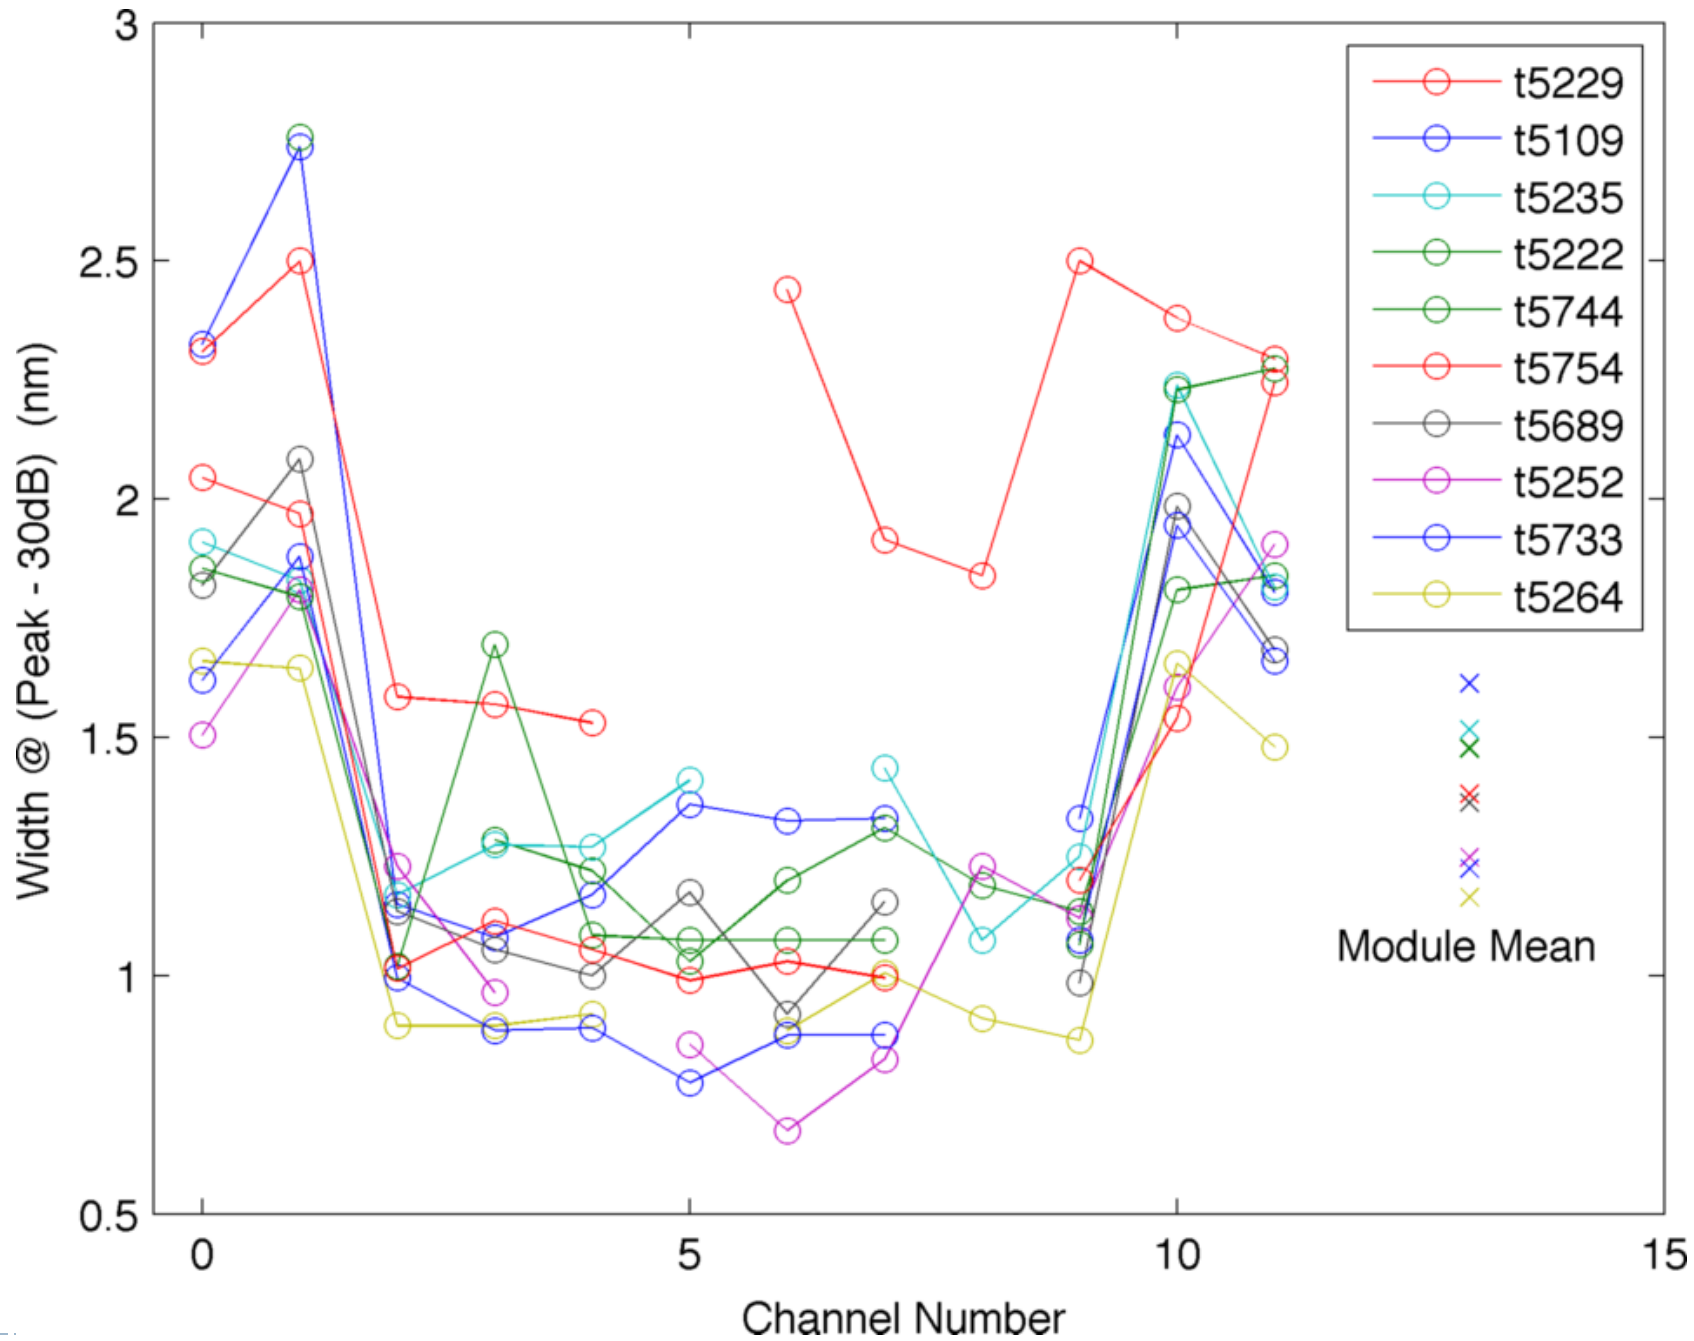
Optical Spectrum Studies

- ▶ Measure optical spectra with Optical Spectrum Analyser (suggested by LArg group after they had some VCSEL failures)
- ▶ Define width at (peak amplitude – 30) dBm
 - ▶ Very sensitive to higher order transverse modes.
- ▶ Widths of channels that have been operated are narrower than those that have not
- ▶ Look at pixel TXs which had 8 out of 12 channels operated (next slide)
- ▶ OSA measurements can indicate a damage of the laser before power falls.

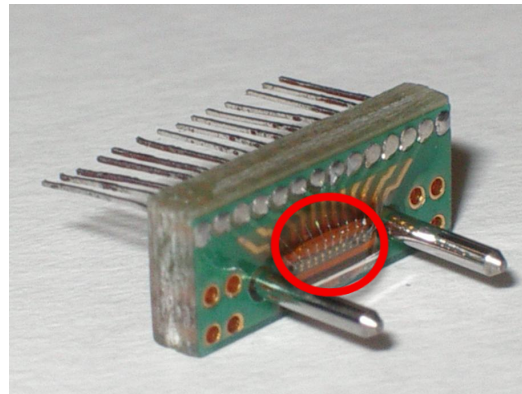
Possible Causes of Failure (2)

- ▶ Truelight VCSEL array was modified to obtain increased power by adding a passivation layer (SiN)
- ▶ Gives lower reflectivity → higher threshold and higher slope efficiency → higher power at 10 mA.
- ▶ Device could be more sensitive to oxidation? Might explain damage growing from outside of oxide aperture towards inside, hence loss of higher order modes and narrower spectra.

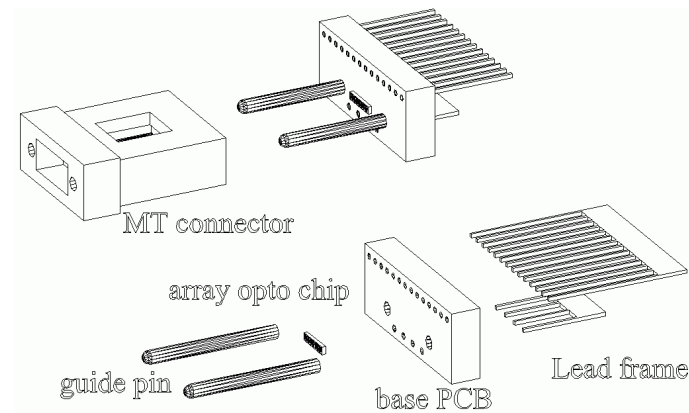
Possible Causes of Failure (3)

- ▶ Damage from wire bonding
 - ▶ Standard gold wire bond process used
- ▶ Epoxy on VCSEL surface causing strain?
- ▶ Infineon spring exerting force on VCSEL and causing damage to lattice?

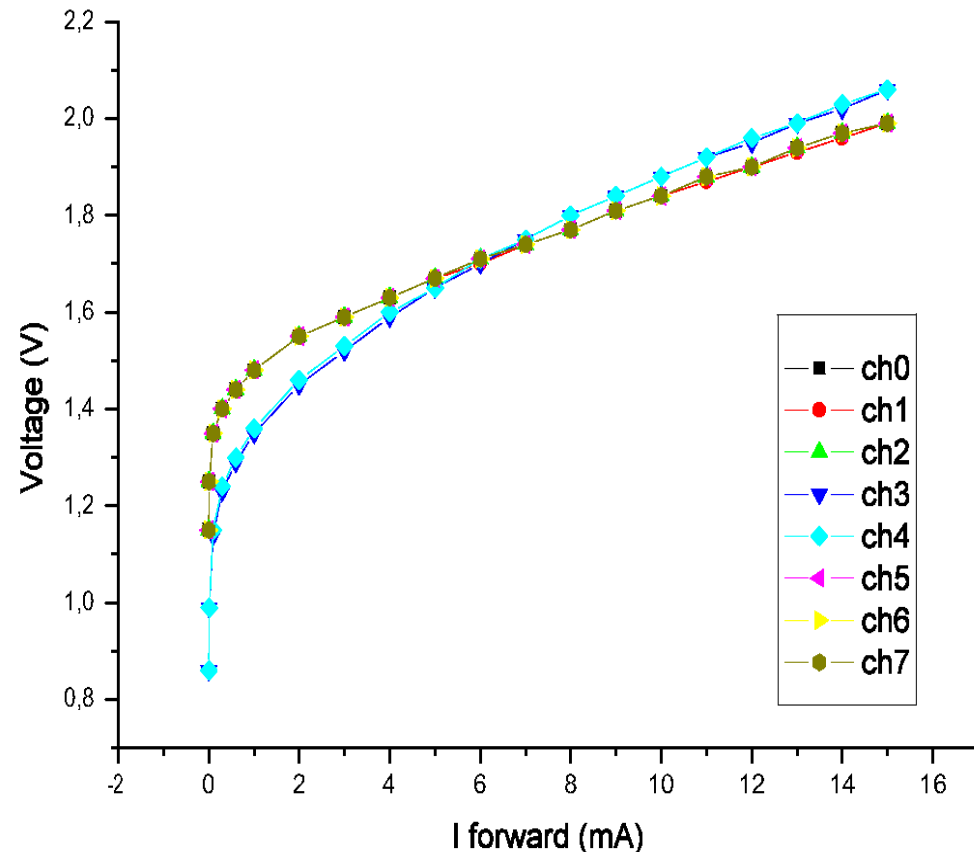
First Failures

- ▶ Many failures with original production in 2008.
- ▶ Dead channels showed shifted IV curves
- ▶ Consistent with ESD.
- ▶ VCSELs are very sensitive to low level ESD (damage threshold 400V).

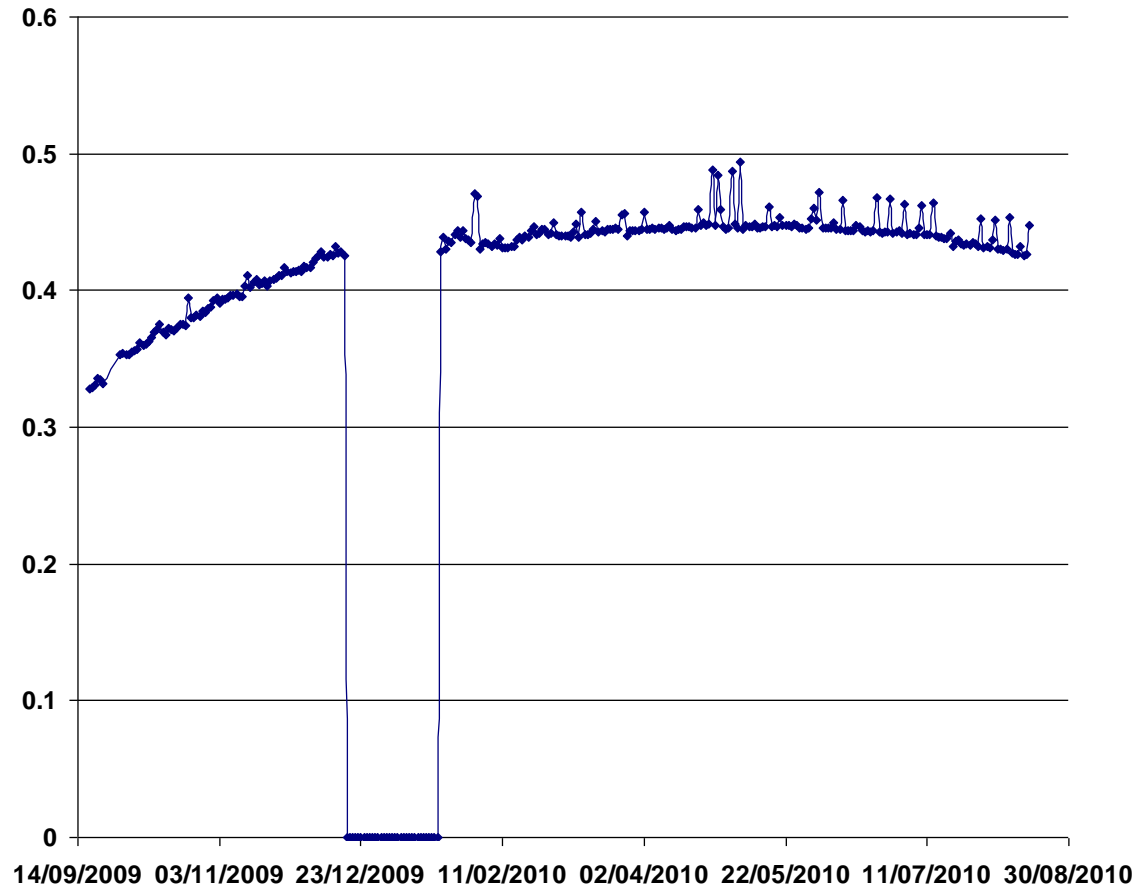
Ipin Stability

Effect of turning down TXDAC values estimated to be 3%

Spikes associated with calibration runs
