SLAC Work Status for the CLIC High Gradient Accelerator Structure R&D

Juwen Wang
CLIC 09
October, 2009

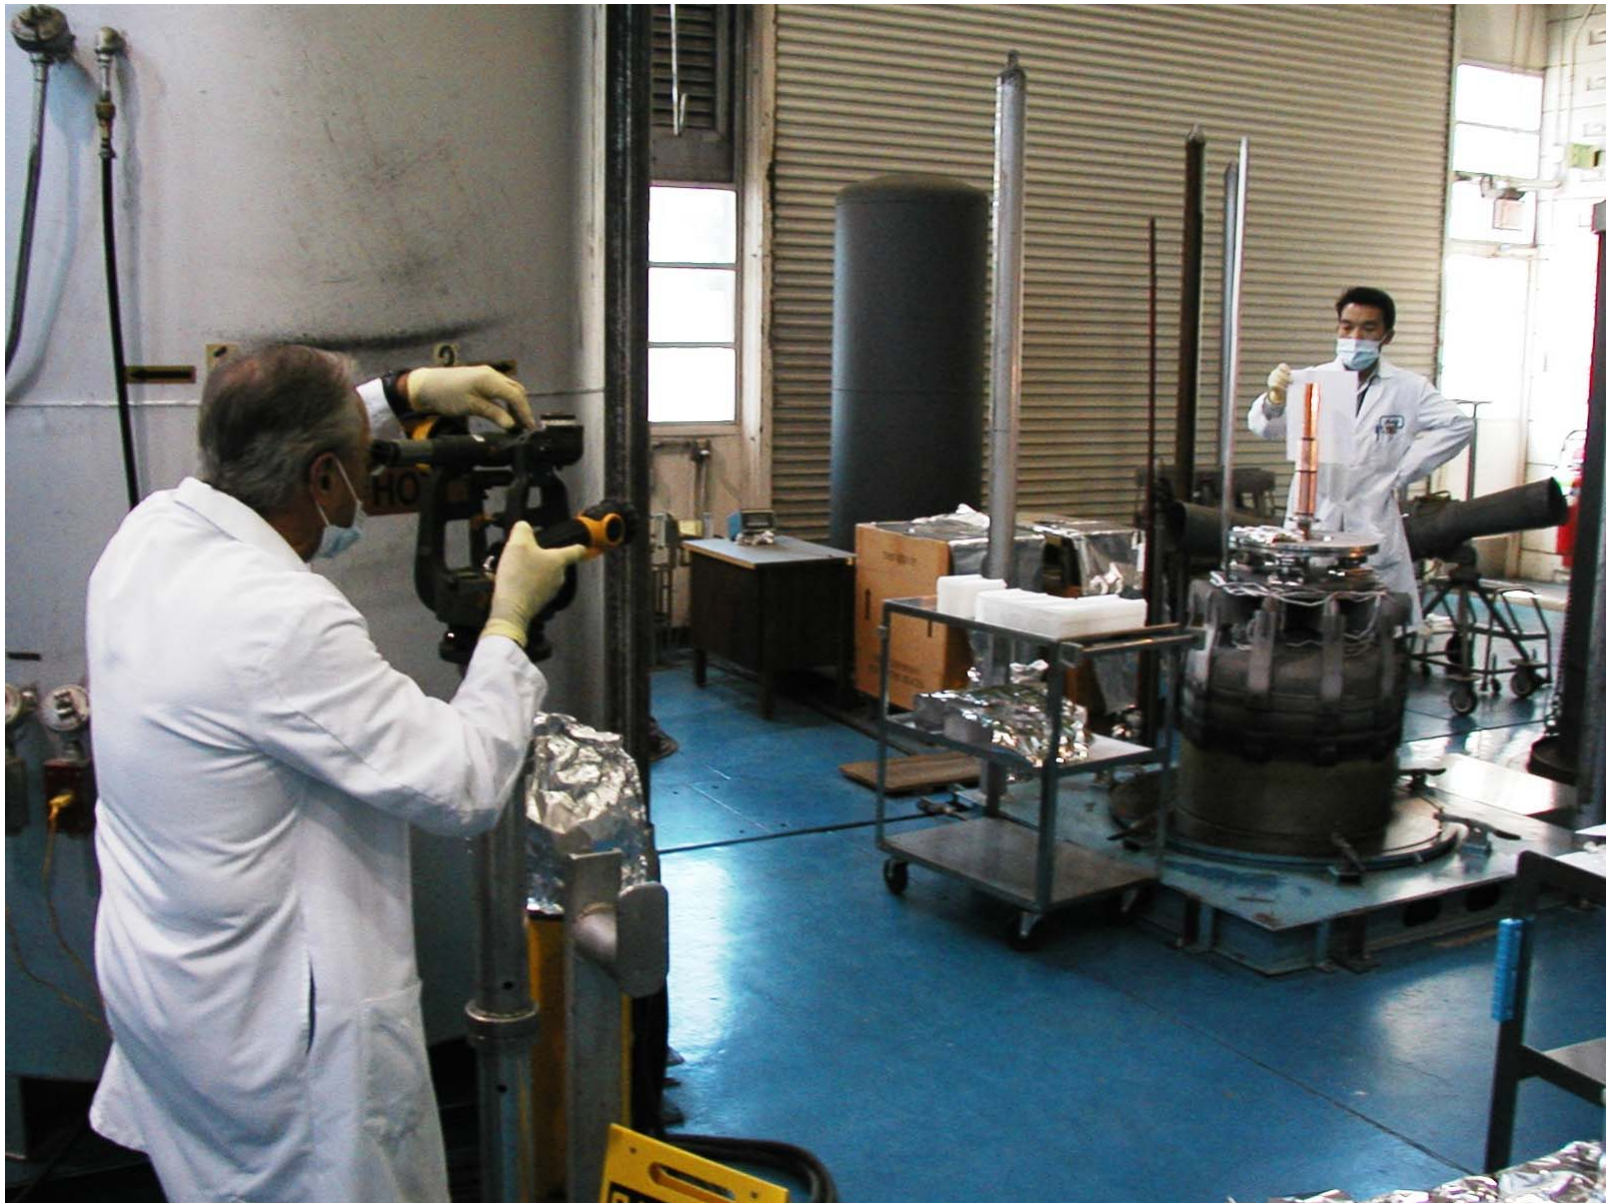
Stacking for Body Bonding of T18_vg2.4_DISC

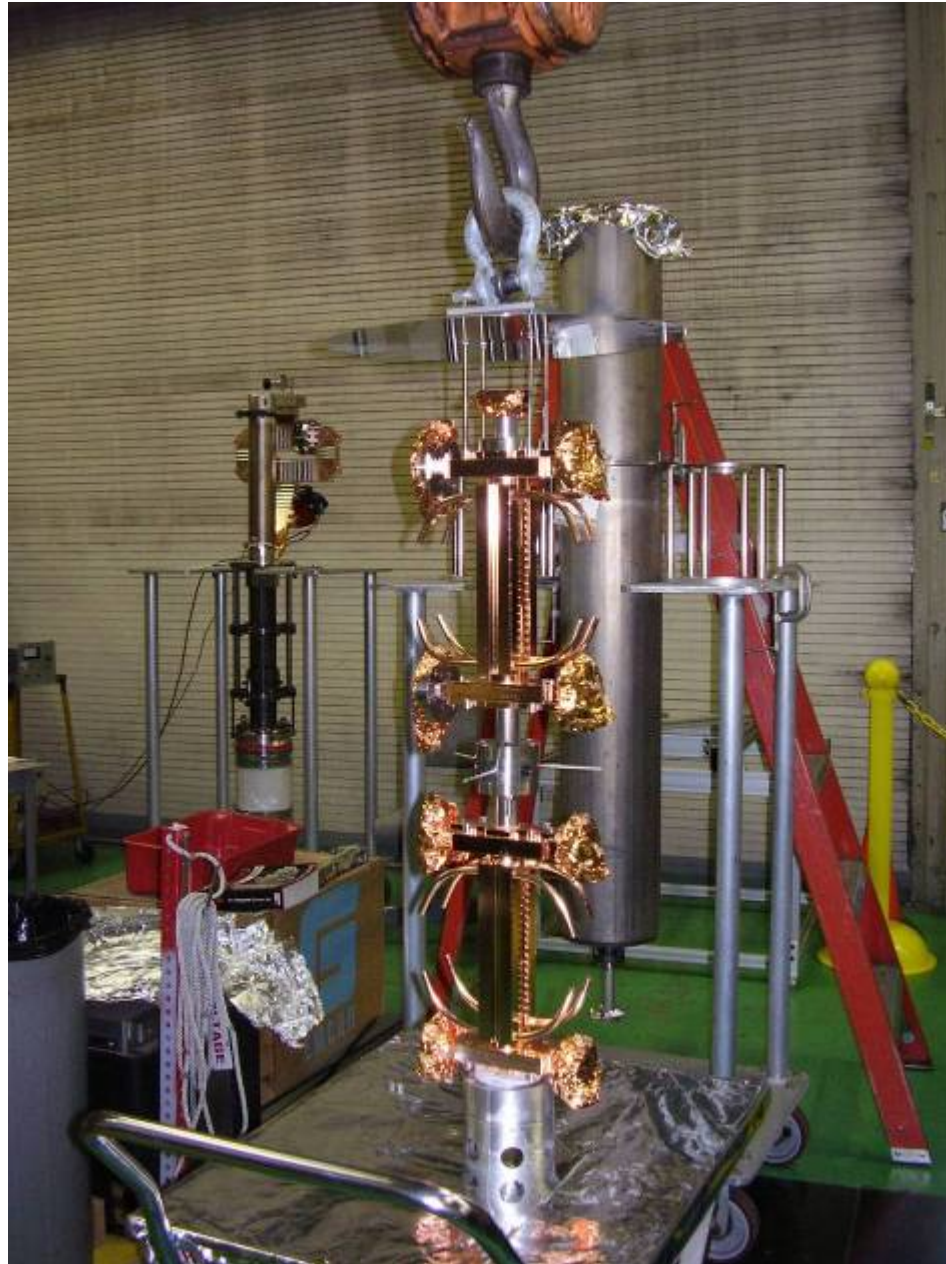
Vacuum Baking of T18_vg2.4_DISC

650° C

10 days
