# High Gradient Performance of CLIC-Designed Structures

Chris Adolphsen

10/12/09

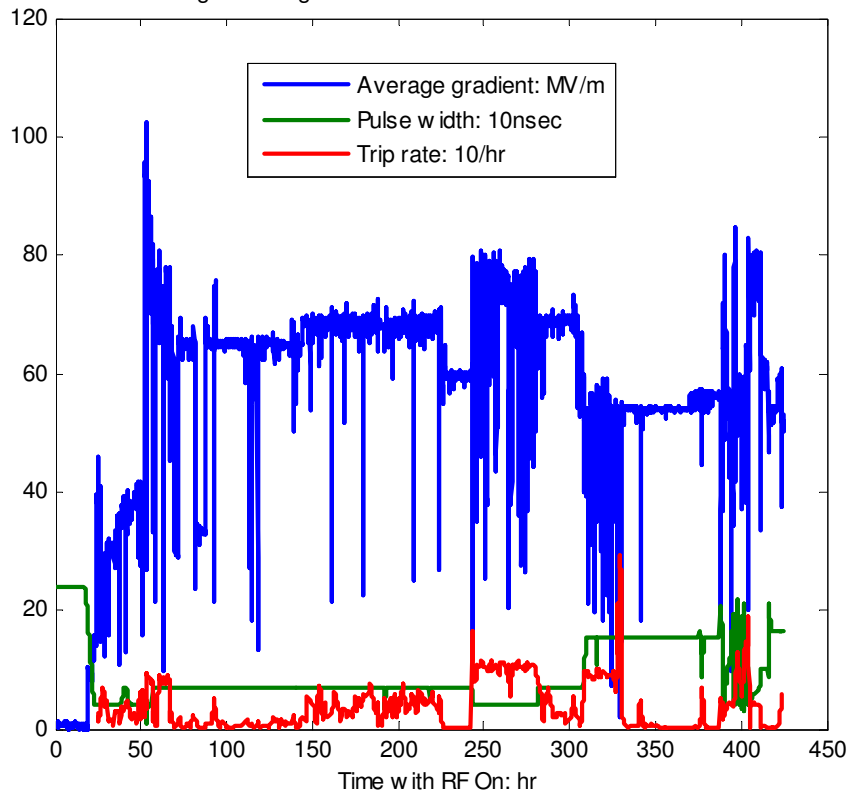
C11g5Q16-original 07-Nov-2006--18-Dec-2006 23:59:43

# First Run

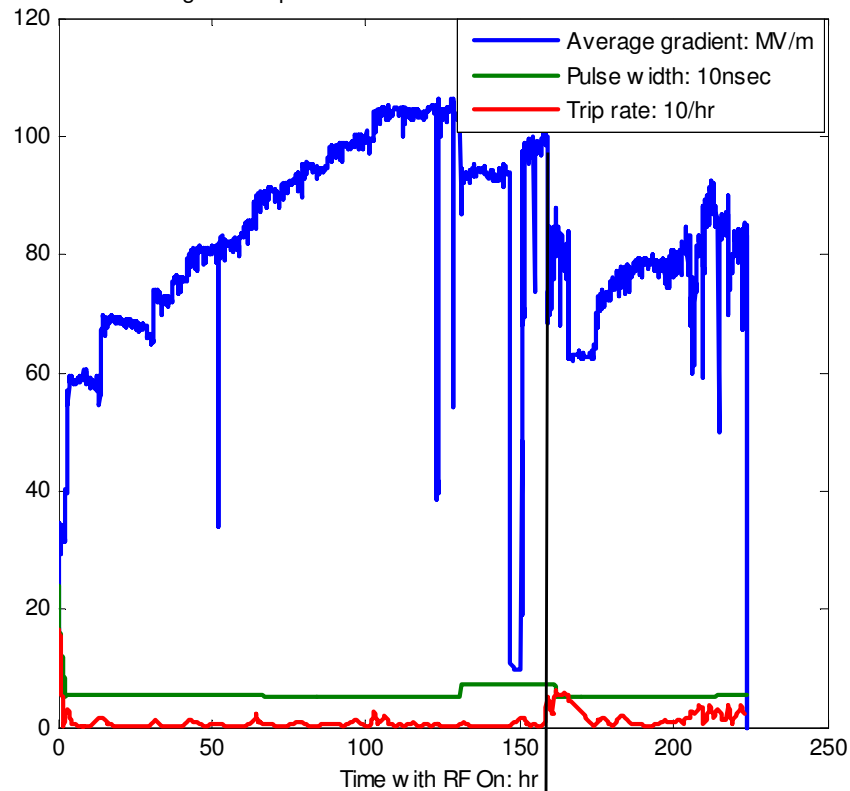
C11g5Q16-repolished 03-Mar-2008--19-Mar-2008 22:59:33

# Second Run

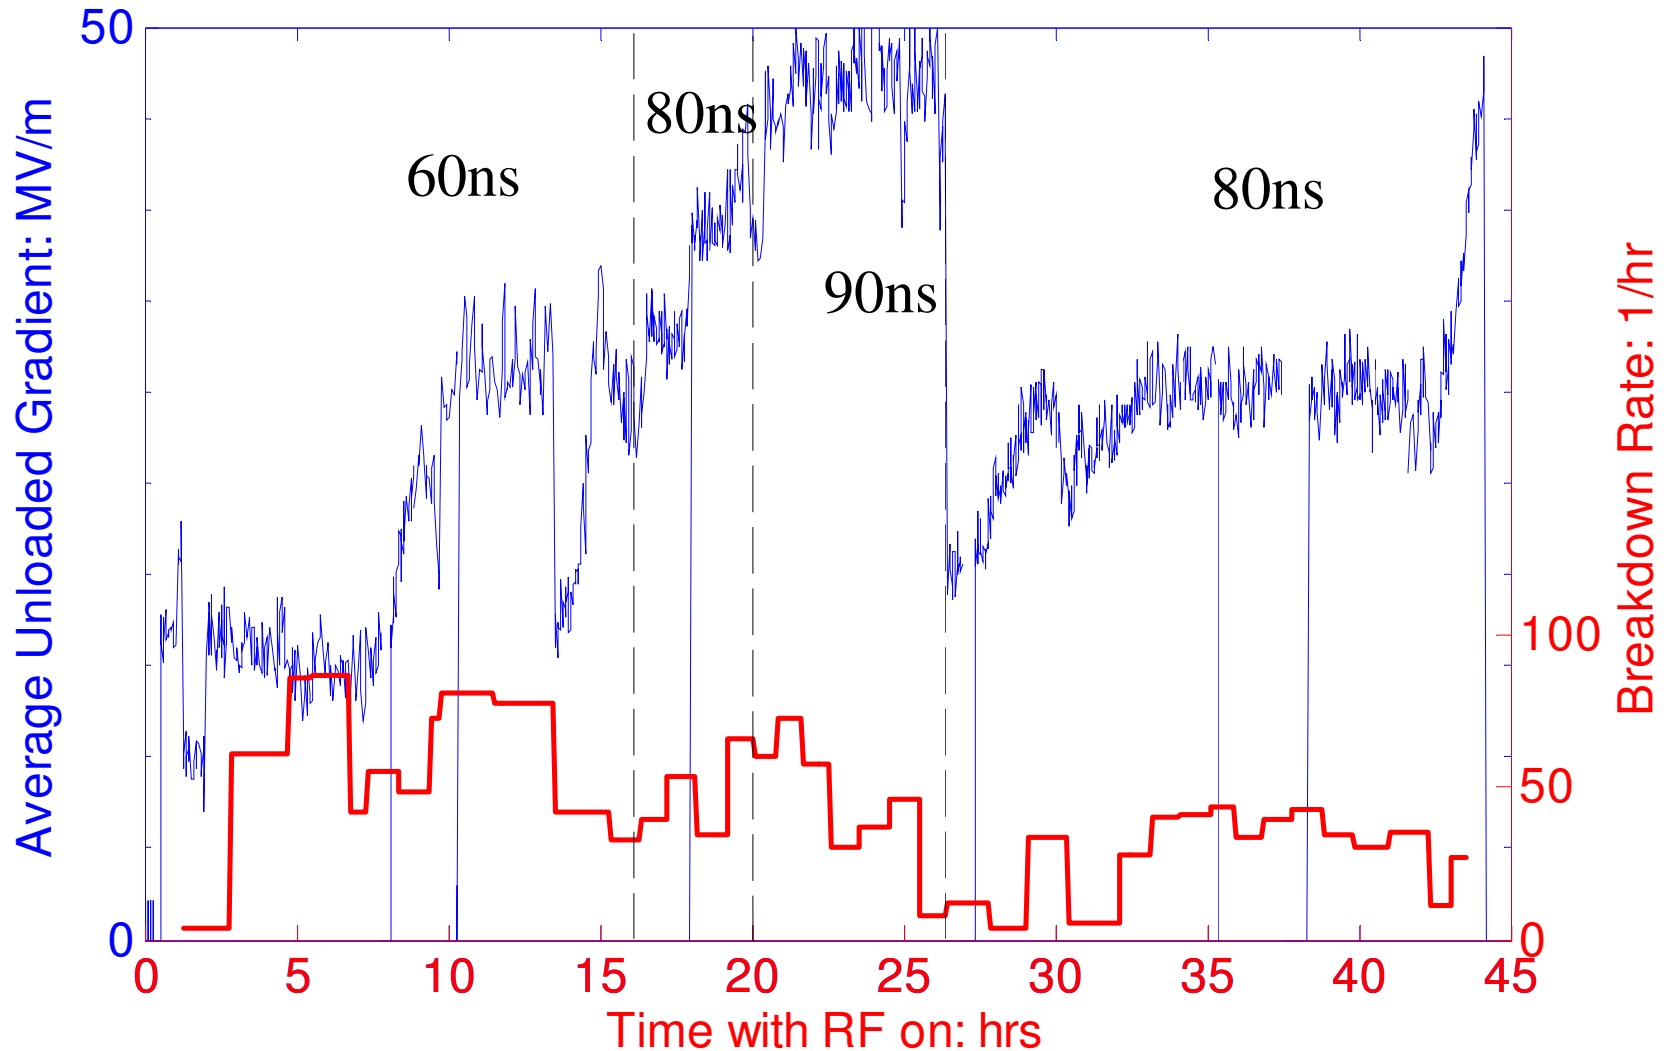
# TD18 Quad Processing History

Breakdowns Located Throughout Structure

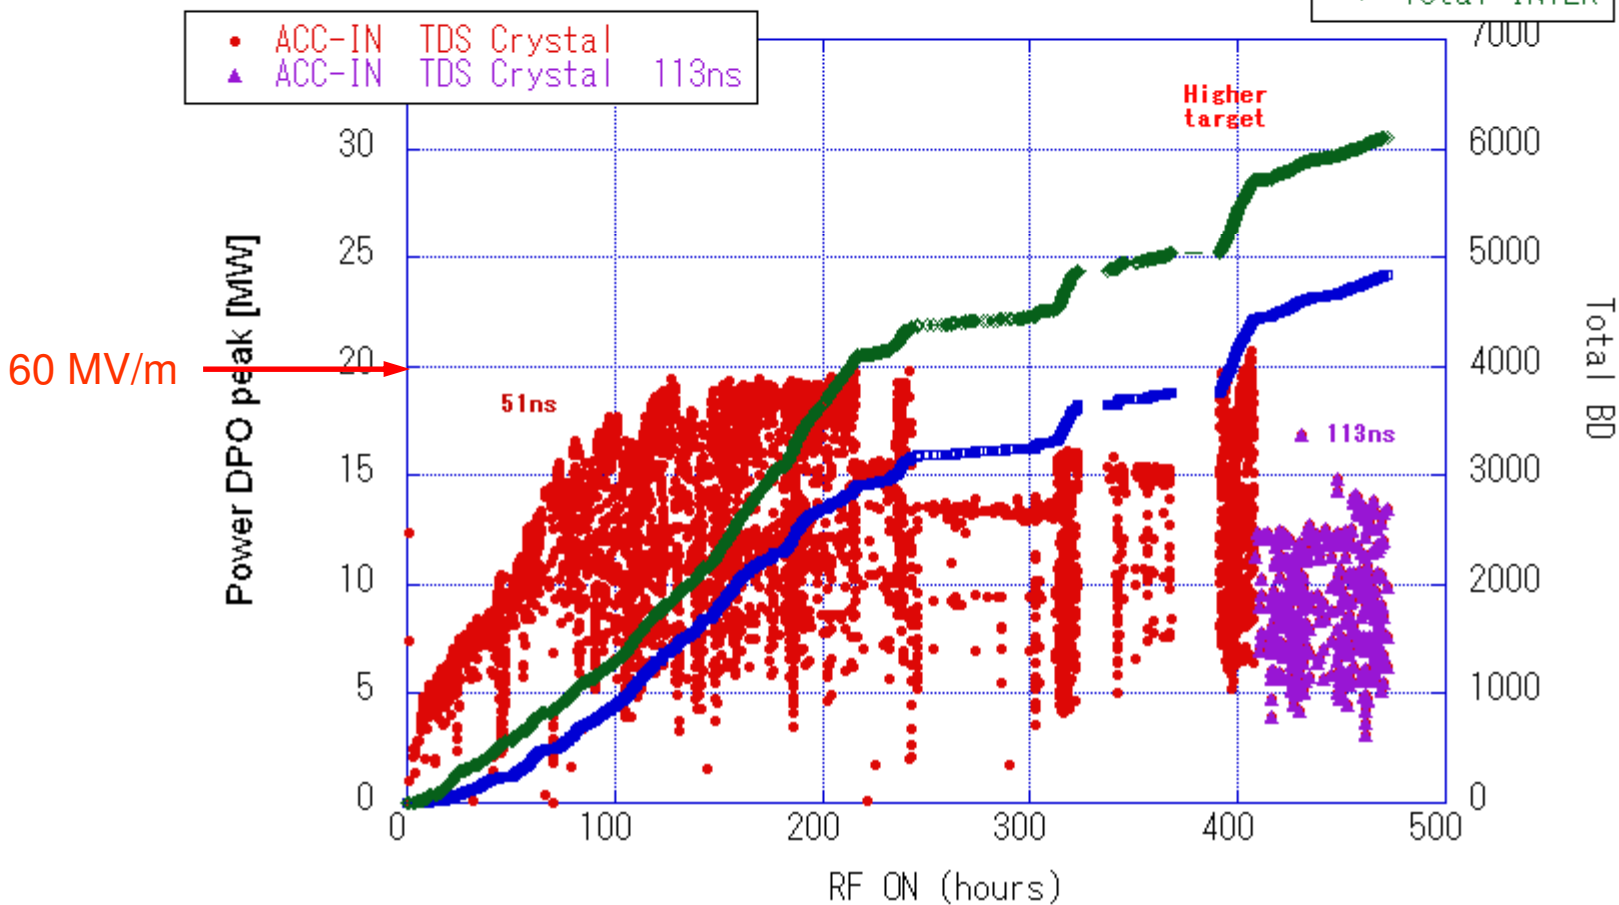
091005 Quad #5  
Initial processing trend

# Recent KEK Results from Testing a TD18 Quad Structure with 50 $\mu\text{m}$ Rounded Iris Edges

All measured data at 70 ns pulse length and  $10^{-3}$  breakdown rate

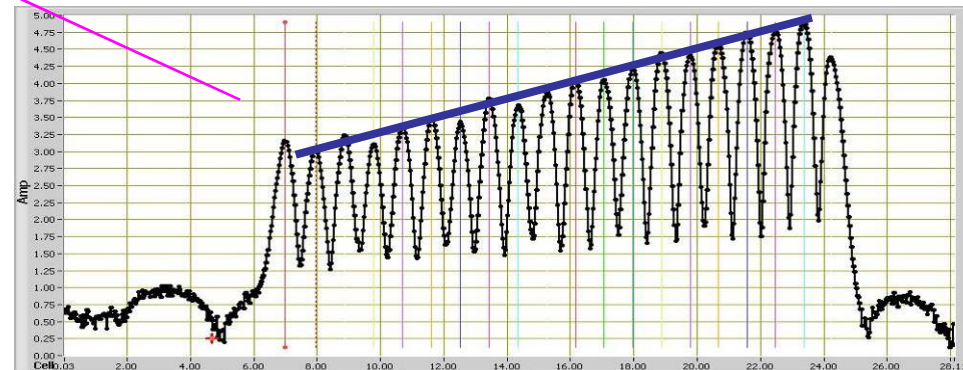
Field Profile Along the Structure
