Overview of all superconducting splices in the LHC machine

N. Catalan Lasheras

Chamonix 2010 LHC Performance Workshop

25 January 2010

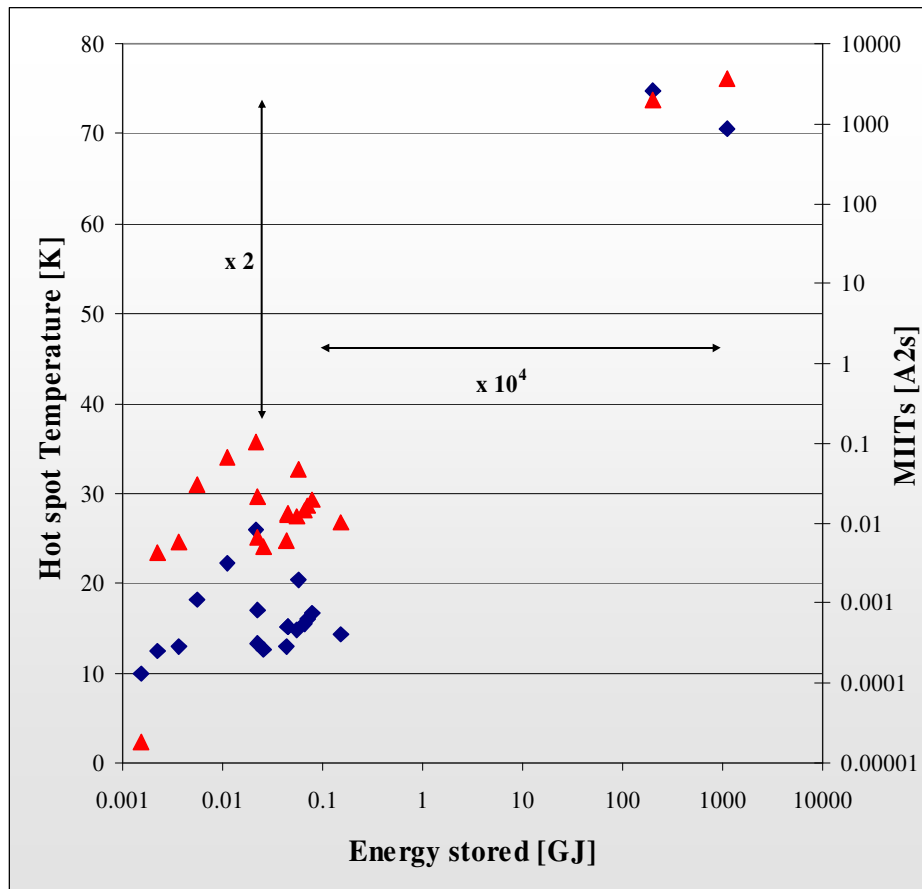
Quench of the bus-bar in adiabatic conditions.
Thanks to G. Kirby

- ➔ Main circuits incorporate more protection
 - Cold diodes
 - Energy Extraction
 - Larger bus-bar cross-section
- ➔ MIITs and hot spot temperature estimated in the bus-bar according to real decay data and bus-bar section
 - Not a factor 10^4 but a factor 2
 - Always safe as in nominal conditions
- ➔ What about failures
 - In the quench detection?
 - In the EE switches opening?

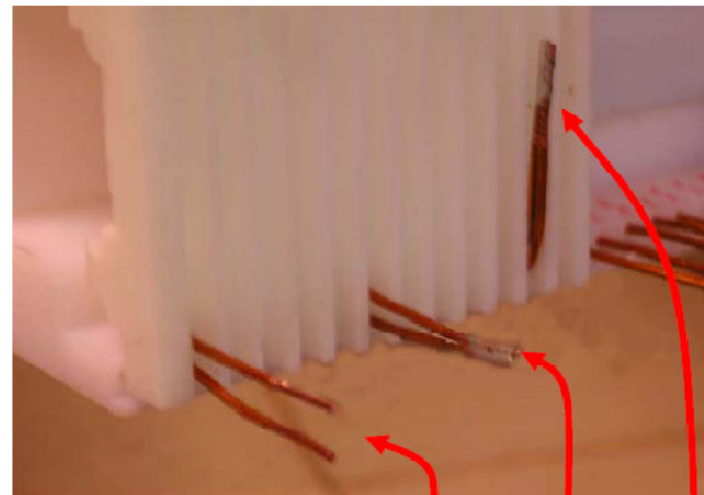
→ Auxiliary busbars : Assembly procedure

- Operation #LI-2-05 "Assemble the connection box"
- Operation #LI-2-06 "Perform electrical test"
- Operation #LI-2-07 "Weld line N auxiliary bus bars"
- Operation #LI-2-08 "Perform electrical test"
- Operation #LI-2-09 "Insulate electrically the aux. Bus bars"
- Operation #LI-2-10 "Perform electrical test"

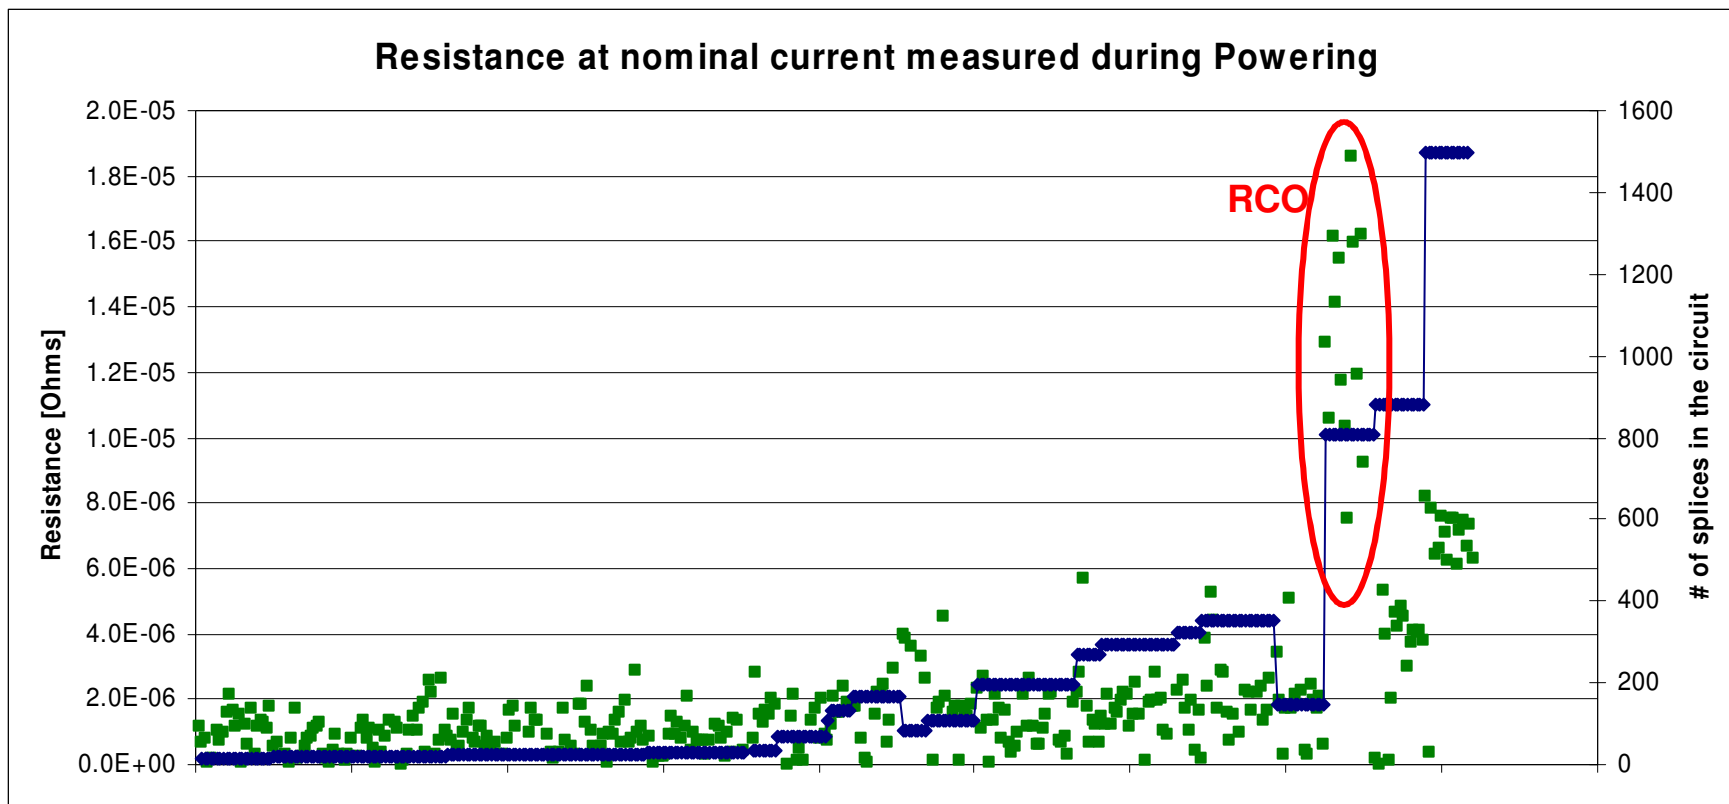
- ➔ Resistance is indeed proportional to the number of splices but noise is very high.
- ➔ Noise depends on the circuit type. Cable length, number of magnets and inductance.
- ➔ RCO circuit is a 120 A circuit and test is done at 100 A.

- ➔ Test systematically done during powering tests for all 600 A circuits
- ➔ Current plateau at minimum current (200 A). Resistance deduced from QPS voltage measurements.
- ➔ Repeated at nominal current. Data stored in MTF
- ➔ Assumed resolution < 1 μΩ
