Davide Tommasini

on behalf of the Norma Team

Status of Spares : inventory

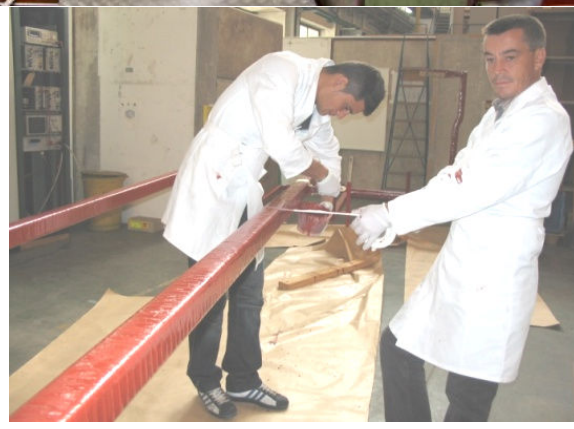
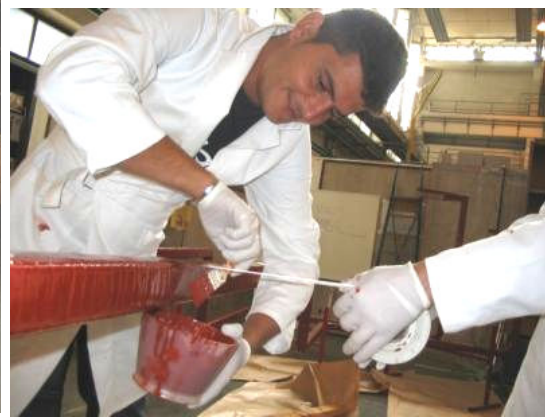
Incident

Insulation failure to ground and between two bus bars, induced by a water leak from a cooling pipe

Removal of the adjacent ground shield and wrapping of the bus bars in insulating sheets (polyimide)

Was performed during a technical stop by replacing the defective bus-bar with a reinforced spare one

Warning : we are missing two types of spare bus bar s !

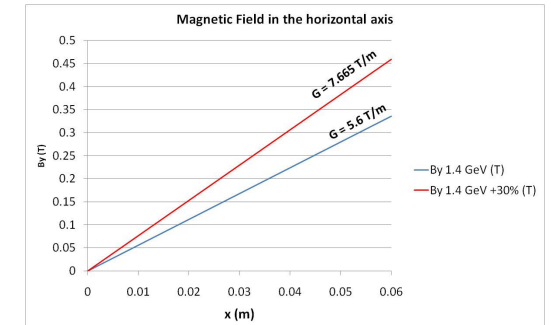
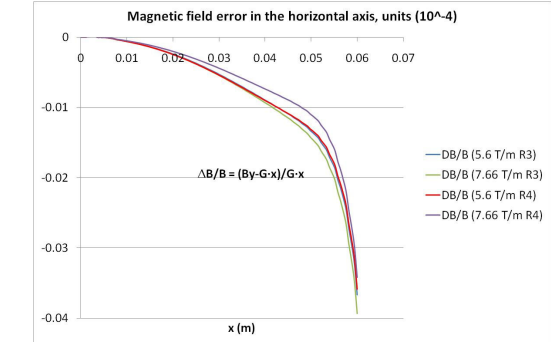
BR.BHZ Normal configuration	Present	+30%
FIELD STRENGTH (T)	0.86	1.12
PEAK CURRENT (A)		
Inner Rings	4032	5255
Outer Rings	4065	5515
POWER COMSUMPTION (kW)	49	83
Q (@ ΔT= 28 K) (l/min)	26	44
ΔT (@ Q = 26 l/min) (K)	28	47

BR.QF	PRESENT	+%30
FIELD GRADIENT (T/m)	5.60	7.66
PEAK CURRENT (A)	4032	5255
POWER COMS. (kW)	16	27
Q (@ ΔT= 20 K) (l/min)	12	20
ΔT (@ Q = 12l/min) (K)	20	34

BR.QD	PRESENT	+%30
FIELD GRADIENT (T/m)	5.60	7.66
PEAK CURRENT (A)	4032	5255
POWER COMS. (kW)	11	19
Q (@ ΔT= 20 K) (l/min)	8	14
ΔT (@ Q = 8.3l/min) (K)	20	34
