VCSEL Failures in ATLAS

T. Flick, University of Wuppertal
TWEPP 2010 Aachen, 20.09-24.09.2010

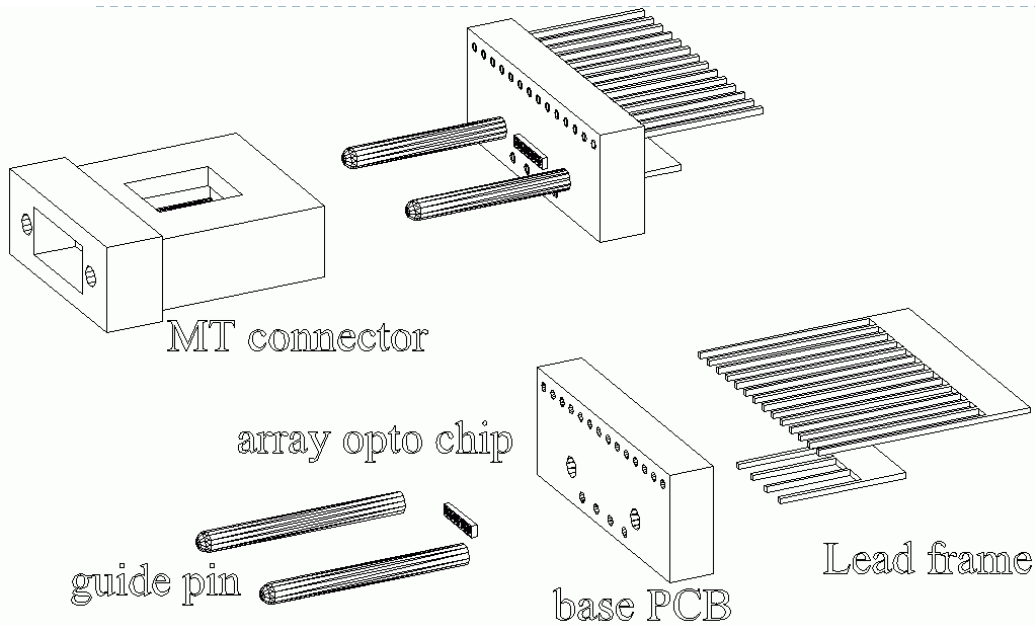
The opto package

Jig used for precision placement of array wrt guide pins → purely passive alignment

MT-connector inside Infineon housing with spring

Epoxy Epo-Tek 353ND over active surface of VCSEL

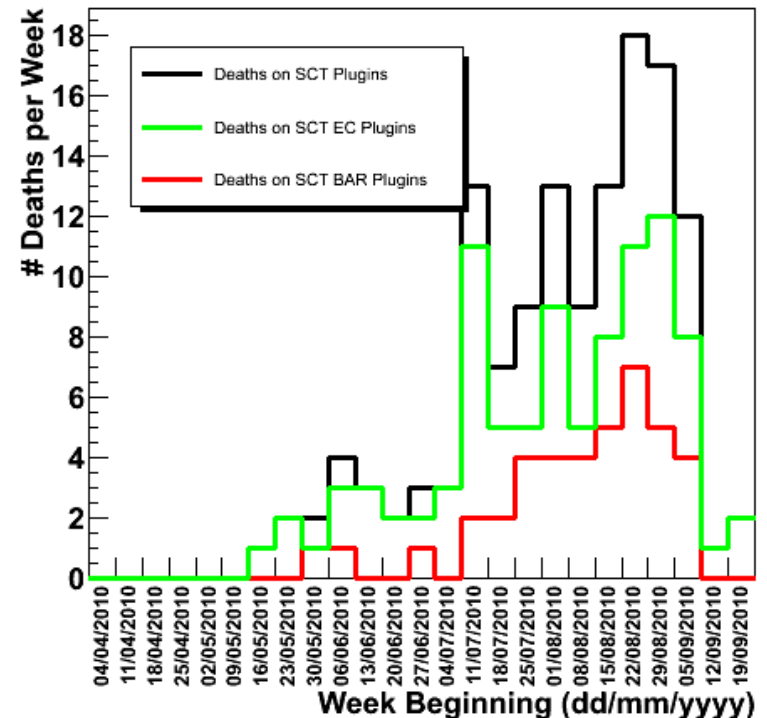
SCT Deaths per Week on All Plugins

~135 failed channels
Rate is ~15/week

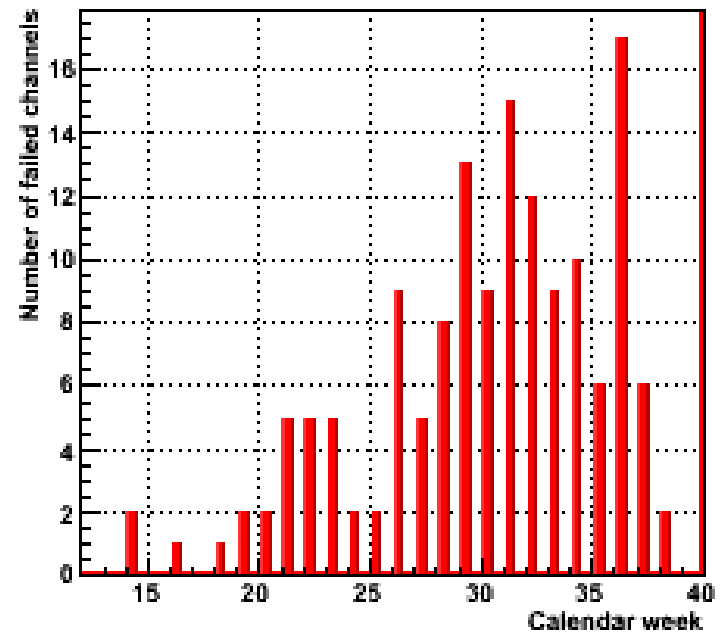
April 08, 2010

~145 failed channels
Rate is ~13/week

- ▶ The light output power of the array is measured in the pixel setup (all channels together).
- ▶ It is stable just before the dead of a channel
- ▶ While dying the light power drops over 5-10 mins.
- ▶ And then it is stable again.
- ▶ The lost channel does not emit any light anymore.

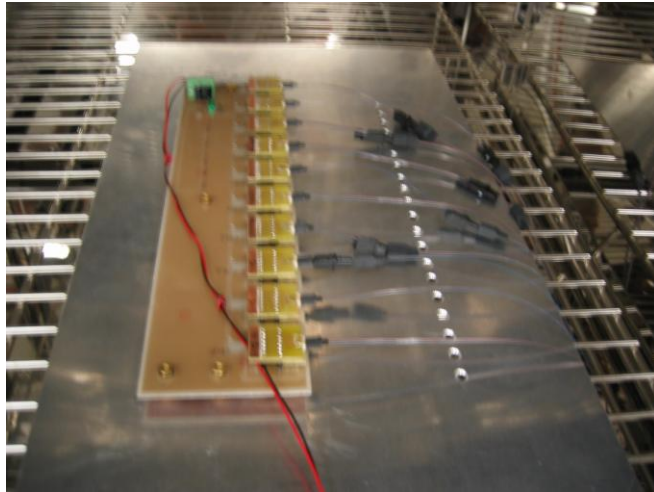
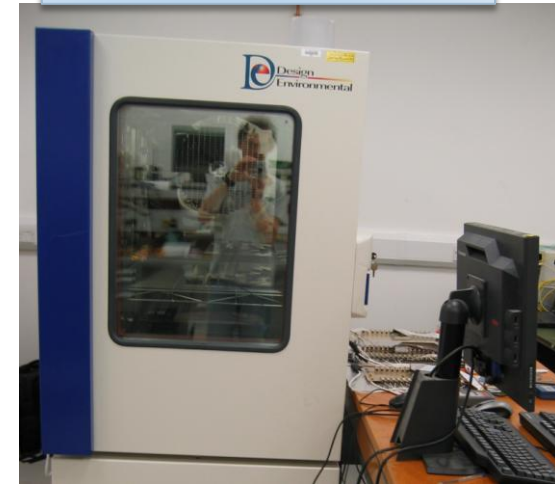
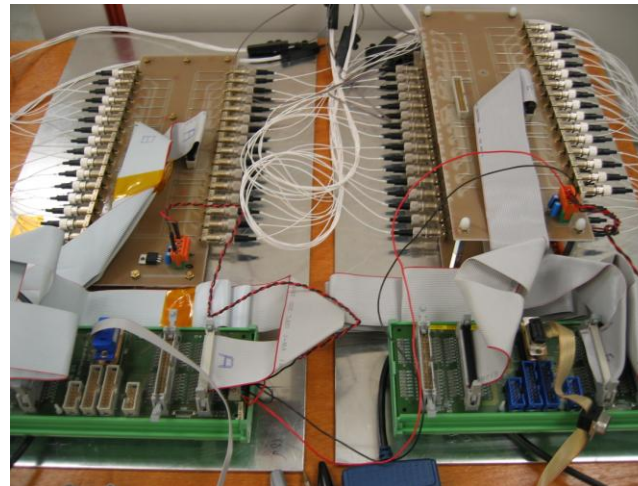
AOC Lifetime Tests

VCSEL arrays on
plug-in PCBs
10 mA DC drive
current.

Environmental
chamber T=70C

Started 4/6/10 no failures so far
Will perform OSA analysis on all channels and on reference array

Photodiodes current read out via standard hardware used in the DCS systems (ELMB).
