Structure Tests, Results and Program

- Introduction
- 30 GHz results and test facilities
- 11.4 GHz results and test facilities
- Future testing program
- Conclusion

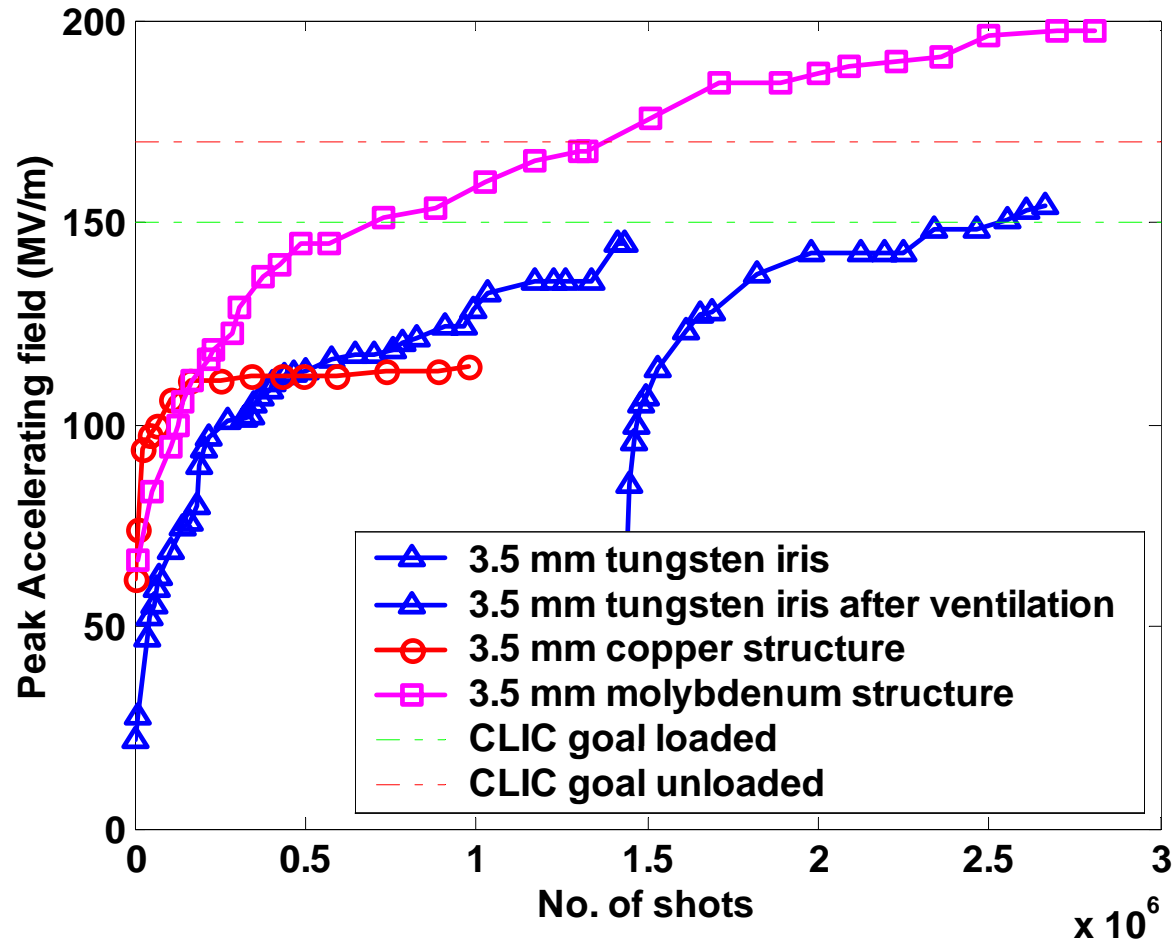
Accelerating Structure Tests in CTF II

Short, 16 ns rf pulses

New Record for classical accelerating structures !

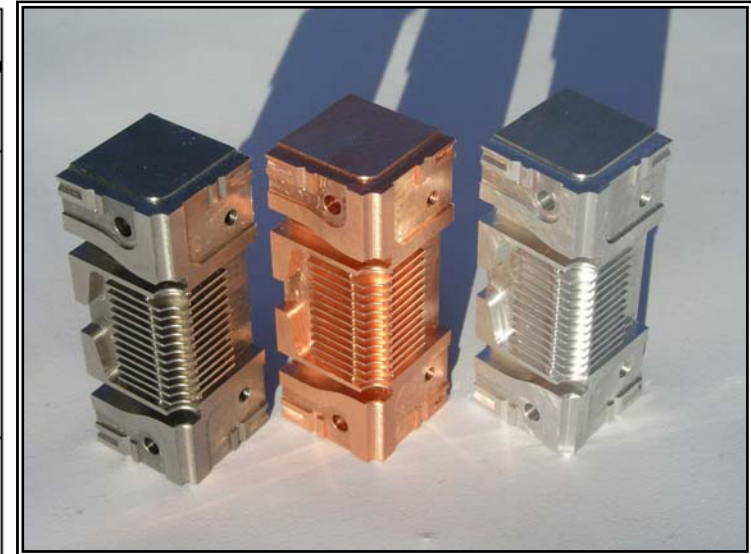
New Materials for High-Gradient

Copper has still the best performance at low break down rate

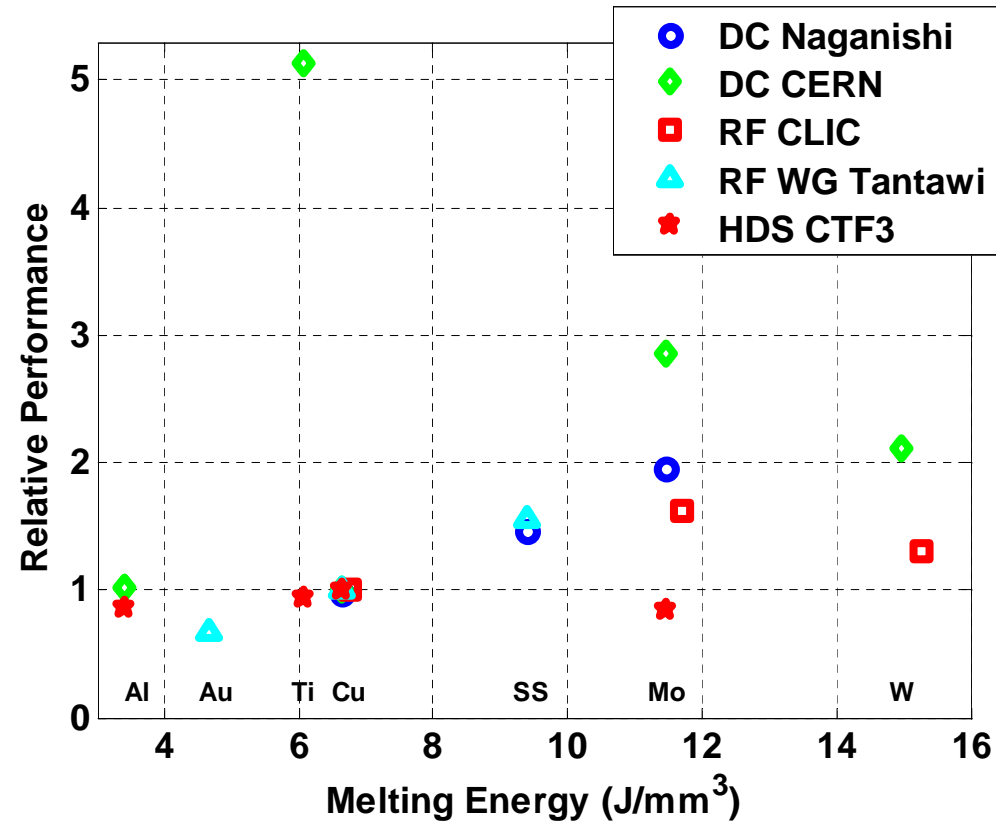
New Materials for High-Gradient

So far, most promising materials have higher melting energy/volume

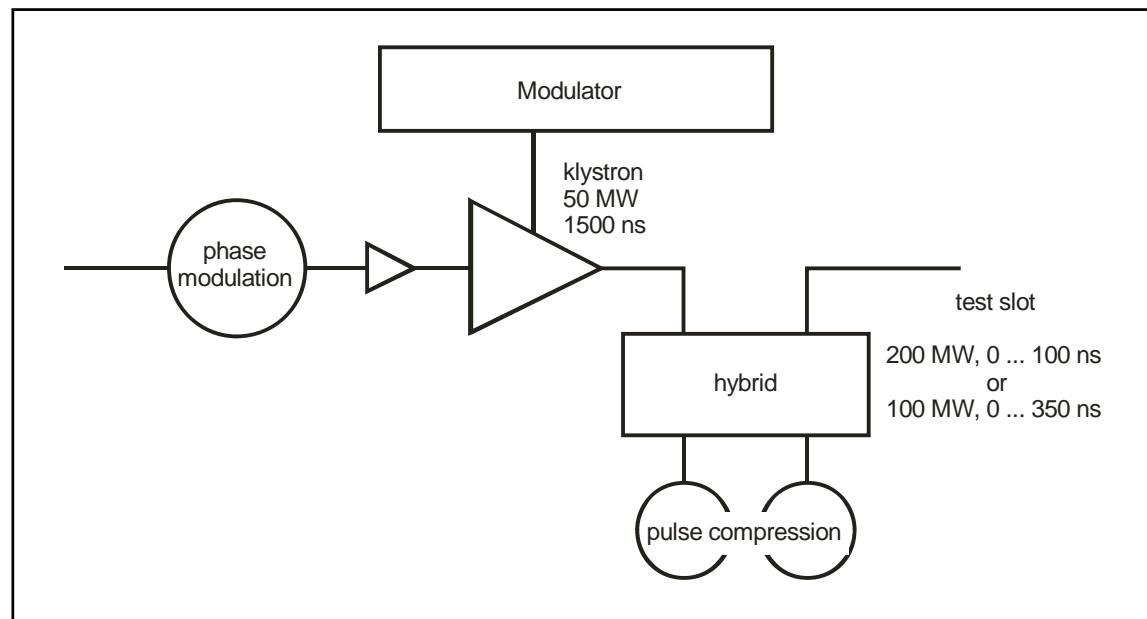
12 GHz stand alone power source

12 GHz power source: PSI INFN-Frascati Trieste

Based on a scaled 11.4 GHz klystron

Independent 24/7 testing with fast turn around

Variable pulse length

Long term testing

Synchronized with CTF3

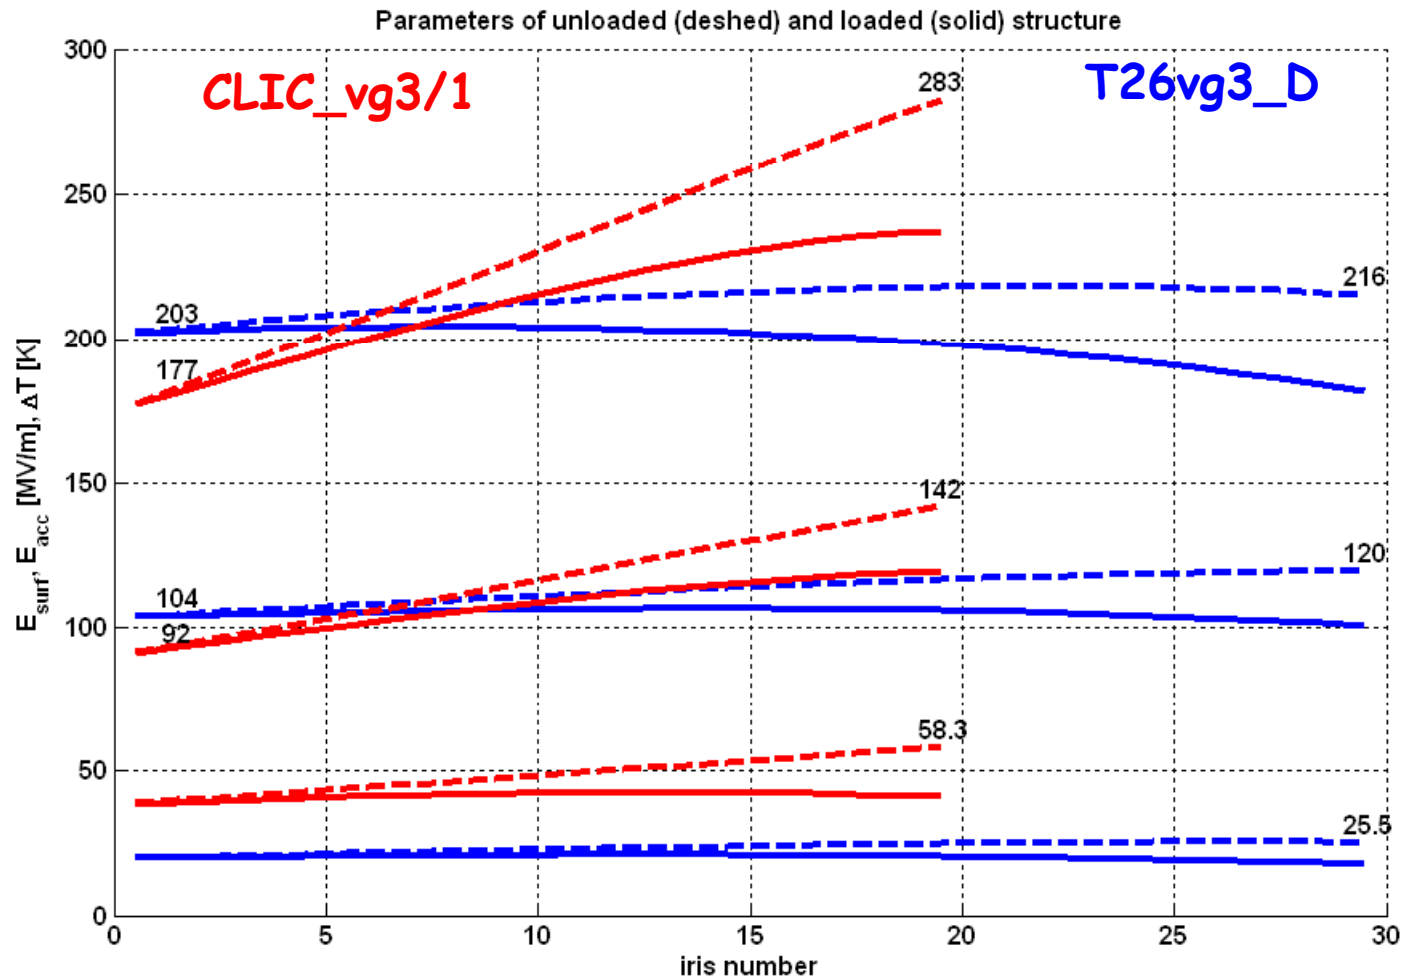
Parameters along the structures

CLIC_vg3/1 is more extreme in maximum surface field, pulsed heating and lowest group velocity
